# Trinidad Campus Residence Hall Complex

Trinidad, Colorado

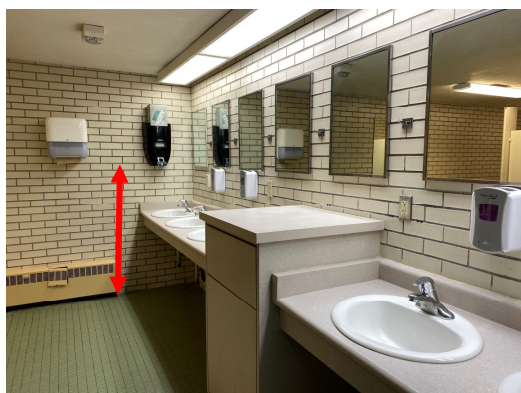
**Figure K.** Plastic laminate countertops appear dated, vulnerable to delamination from high moisture environments. Bottom of mirrors are set high above floor. Source: Hall Architects.

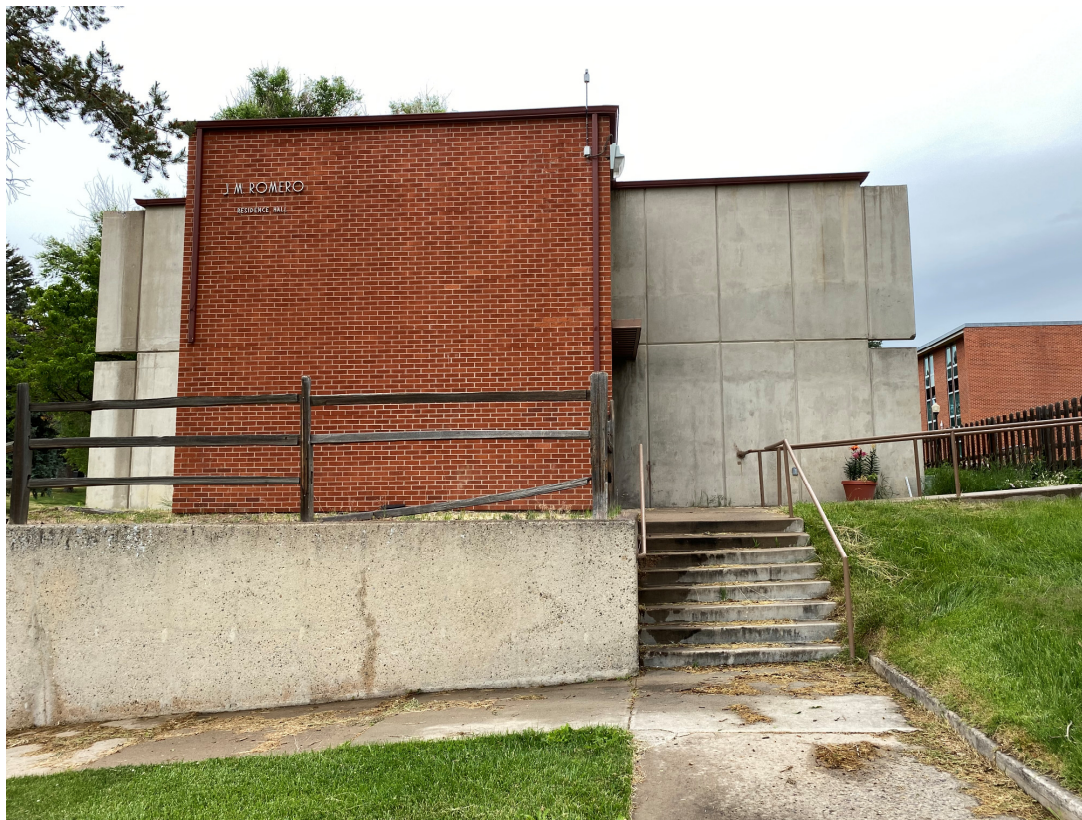
*Figure L. Exterior guardrails at Romero Residence Hall entrance. Source: Hall Architects.*

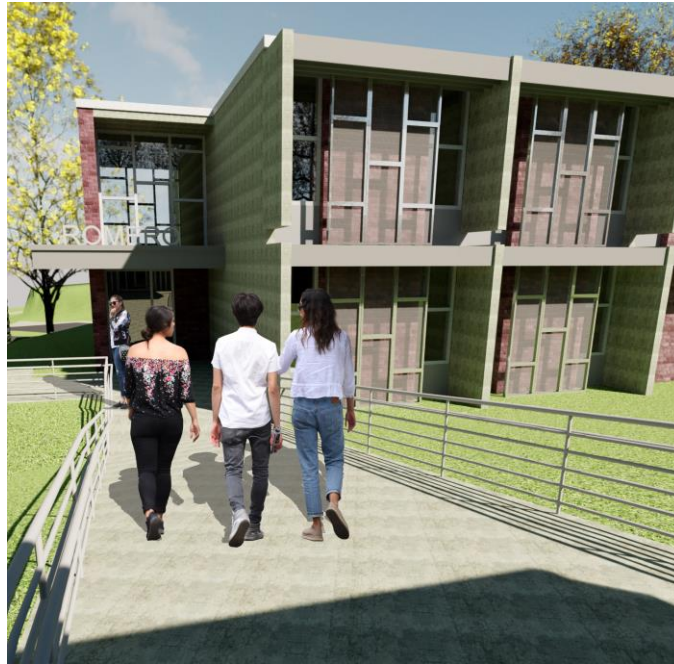
*Existing street-facing Romero Residence Hall entrance.*

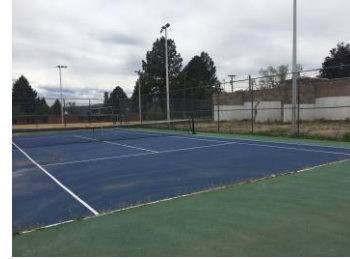
*Existing tennis court north of O'Connor.*

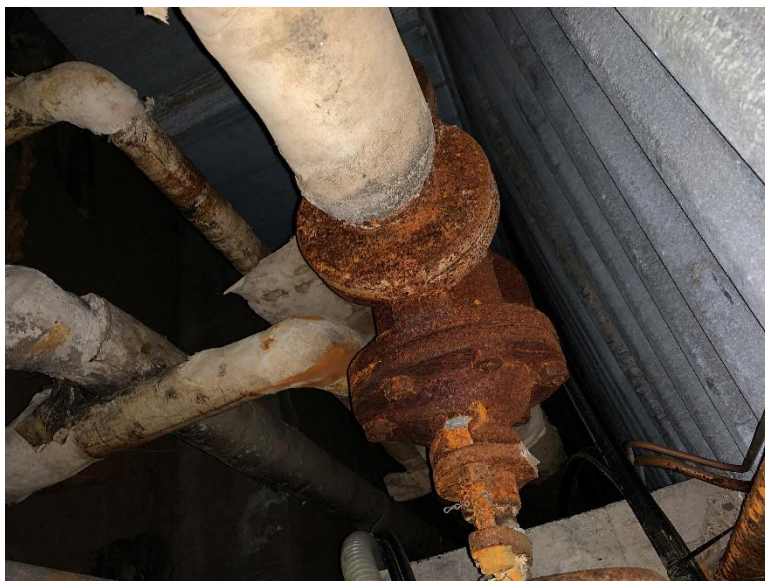
Photo 9: existing gate valve exhibiting extreme corrosion

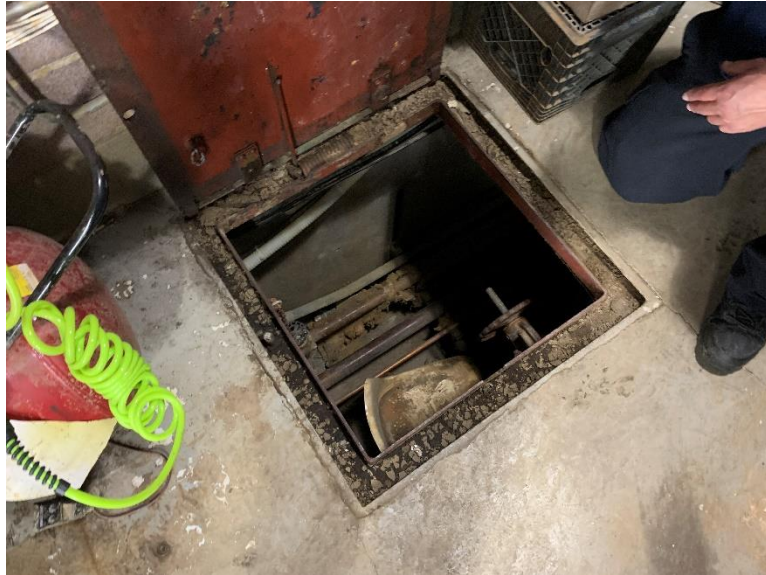
Photo 10: Tunnel access adjacent to air compressor (pneumatic control?)

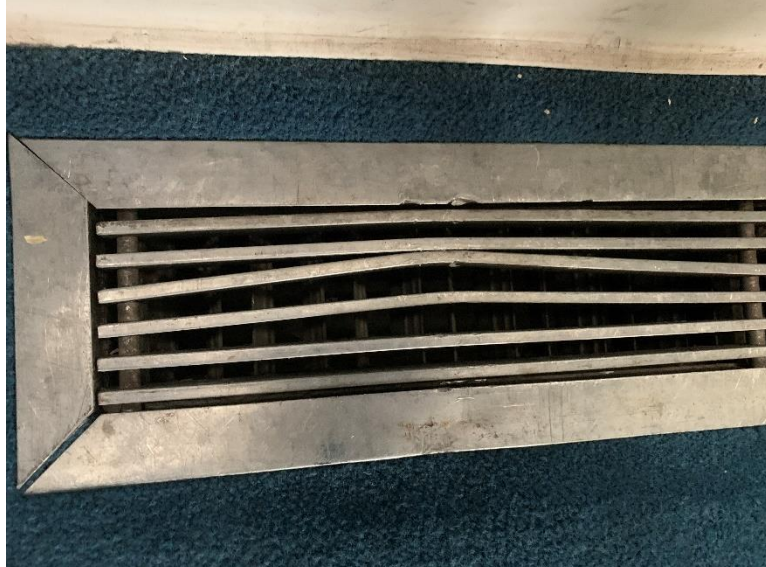
Photo 15: Existing damaged floor diffuser

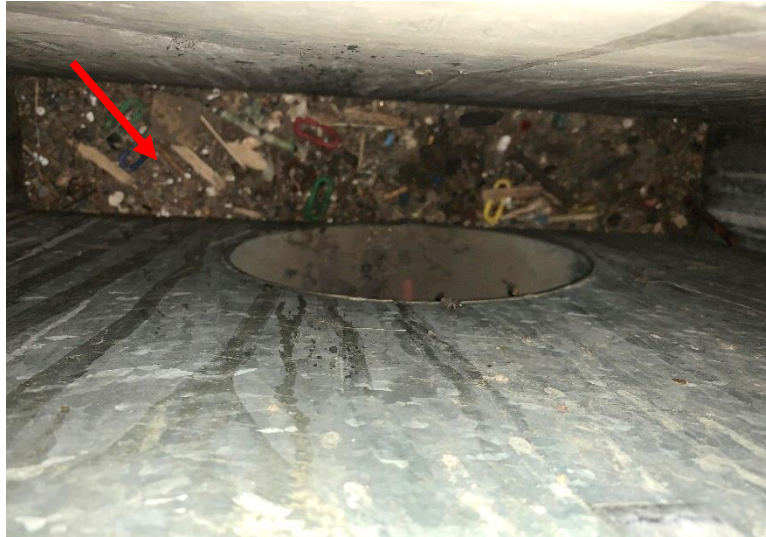
Photo 16: Existing below floor ductwork with accumulation of debris

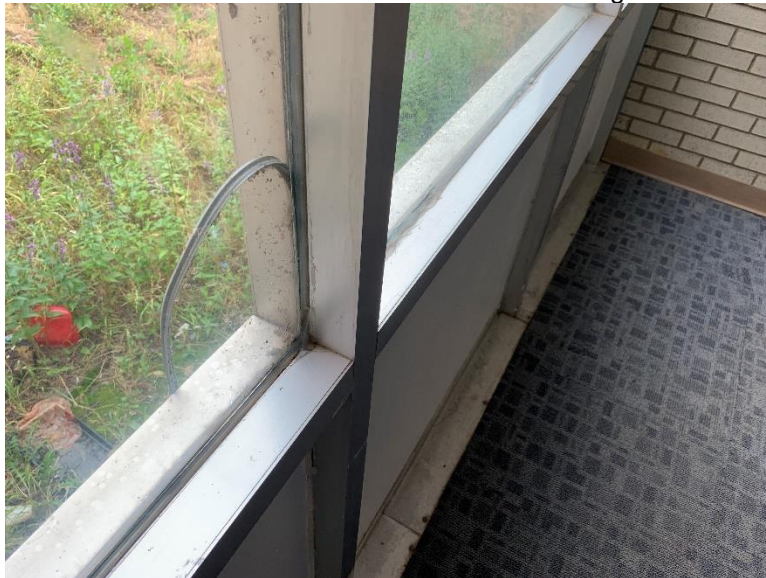
Photo 35: Single pane aluminum window with seal failure

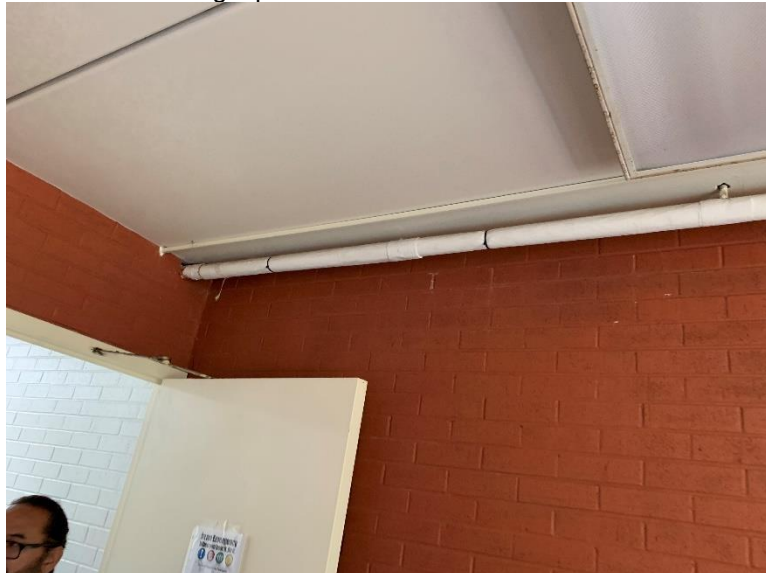
Photo 36: exposed piping in O'Connor dormitory entry

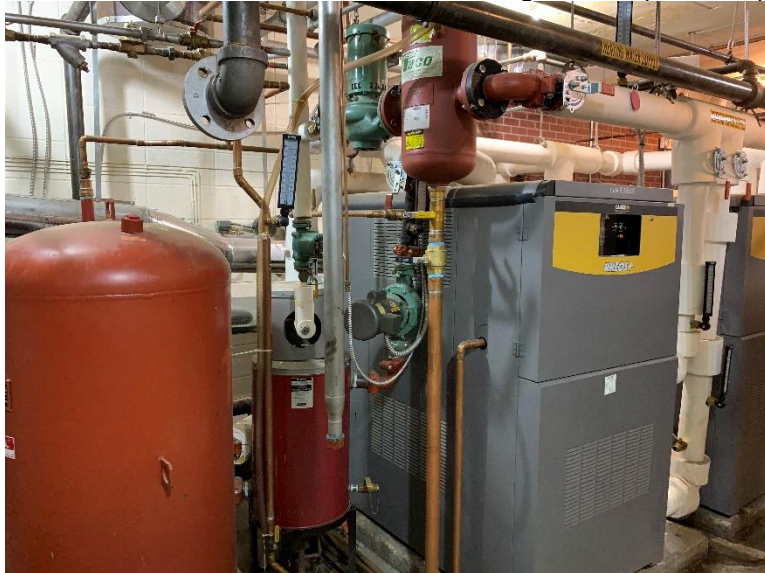
Photo 40: O'Connor Dorm replacement boilers (Laars model no. not legible on photo) installed approximately 2009

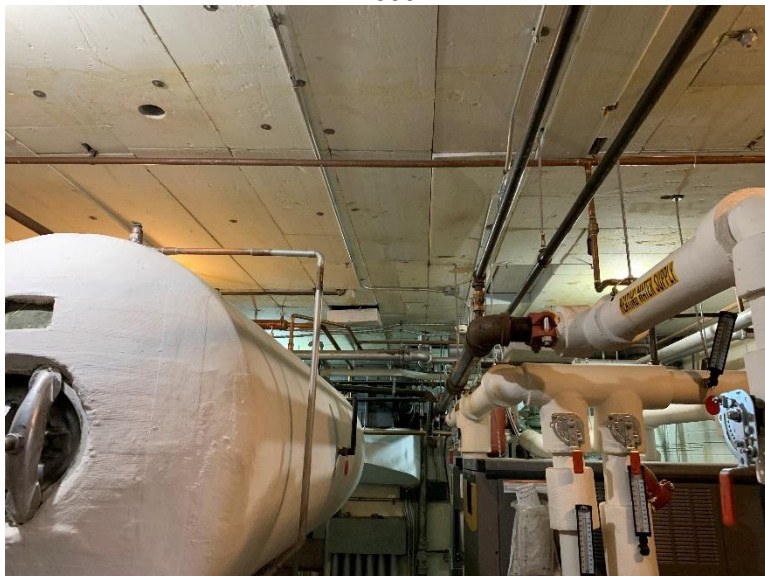
Photo 41: 1964 vintage 790 gal DHW storage tank still utilized

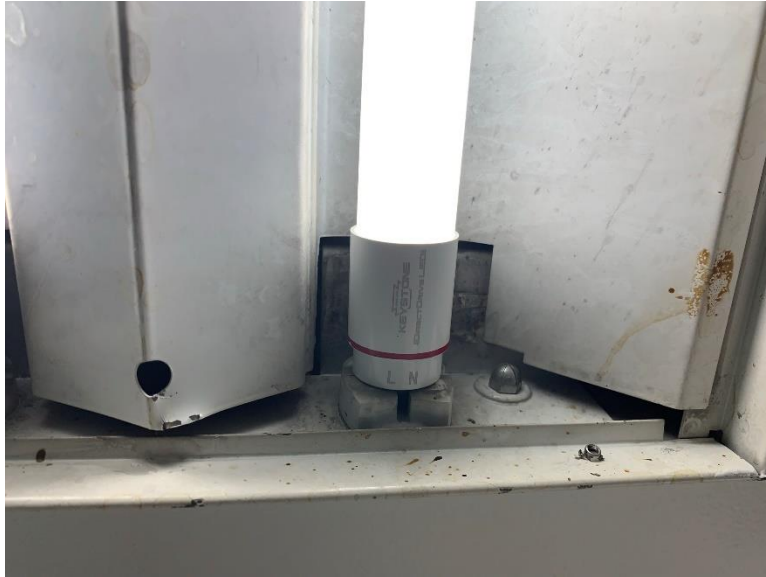
Photo 51: Typical LED fluorescent tube replacement

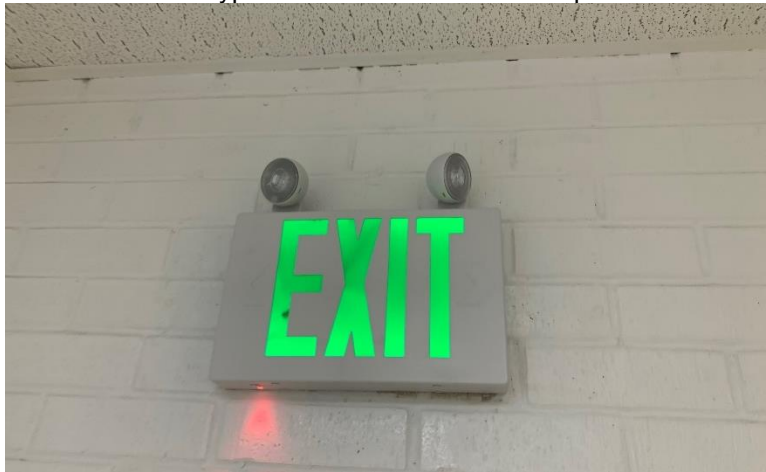
Photo 52: typical LED exit signage with emergency egress heads

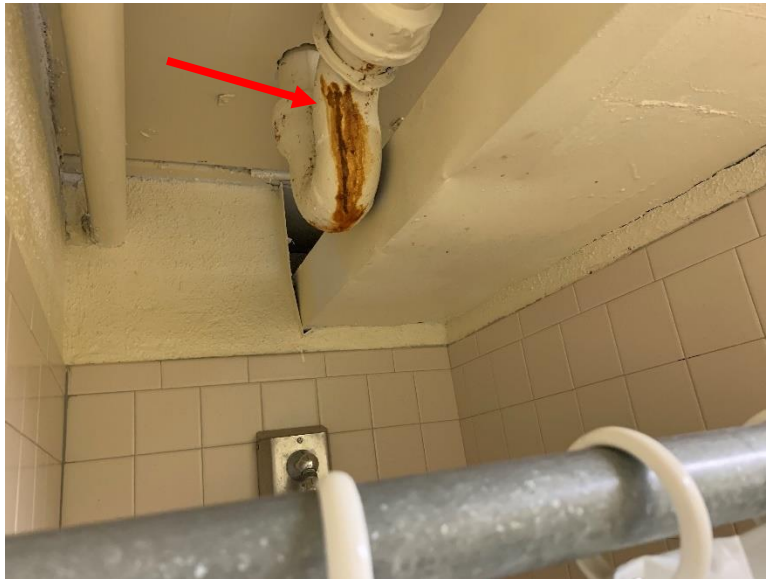
Photo 58: corrosion observed on exposed cast-iron sanitary trap

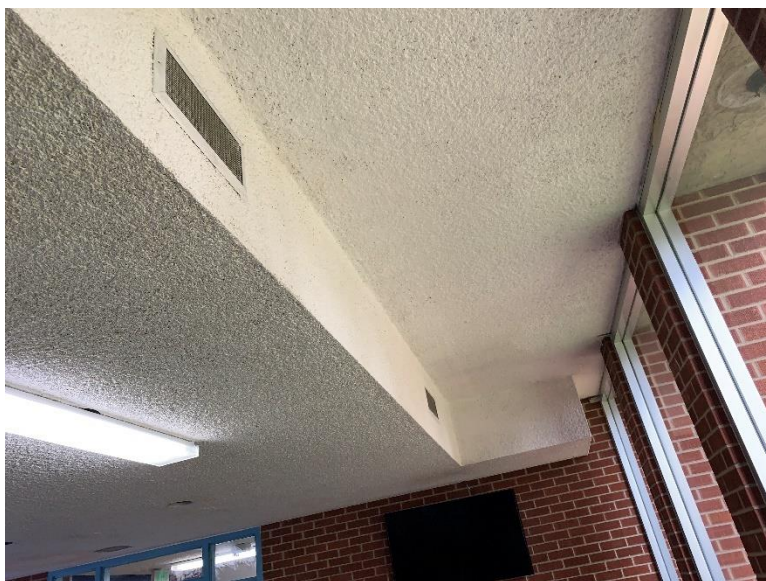
Photo 59: Bulkhead diffusers at Huggins from concealed ducted cabinet unit heaters

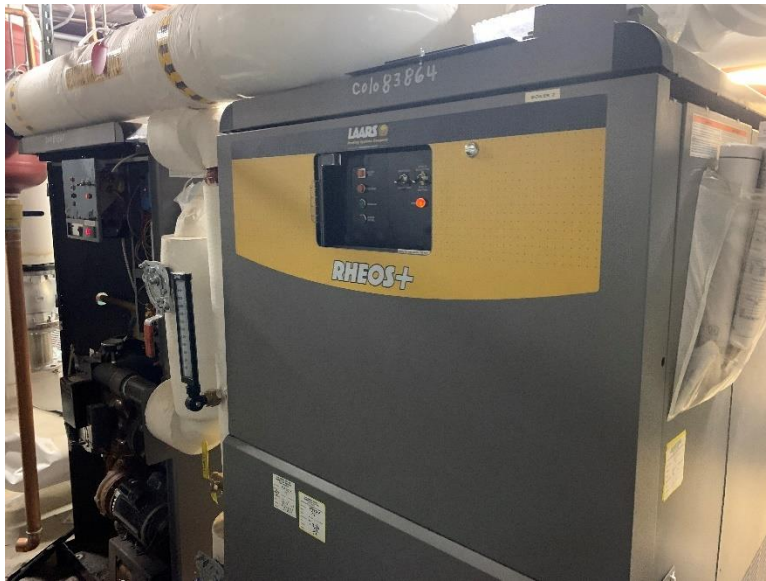
Photo 60: 2009 condensing boiler replacement

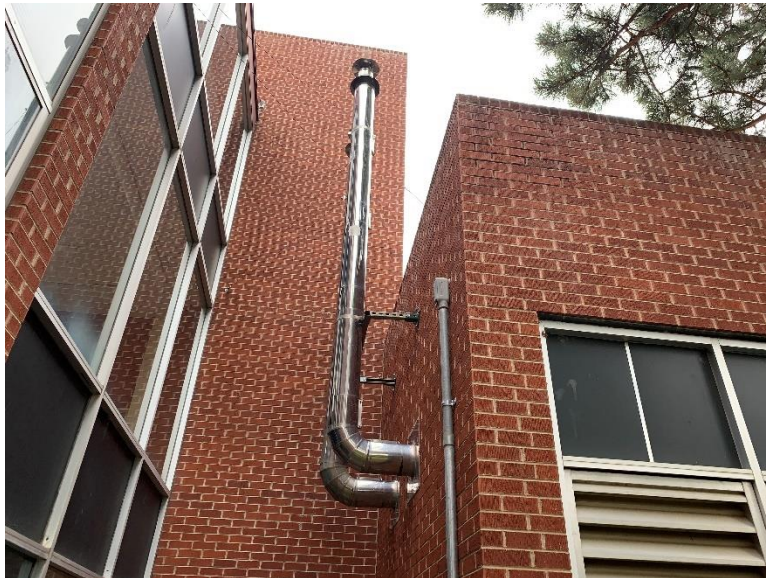
Photo 61: Category 4 A129-4C stainless steel boiler vents

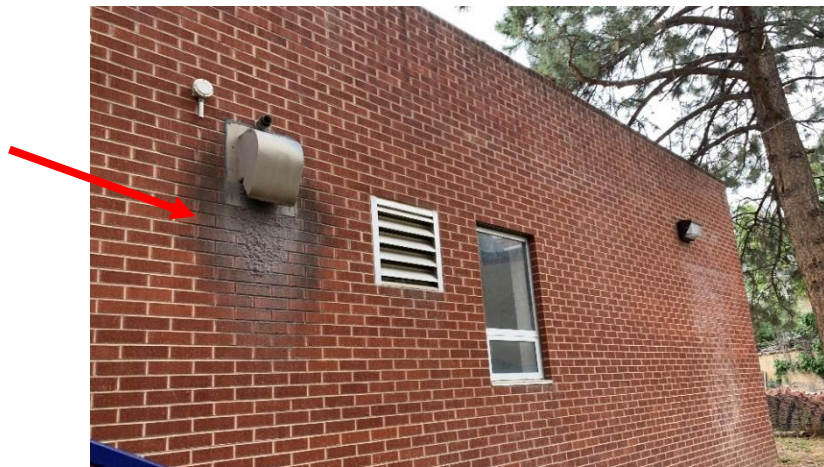
Photo 62: Lint accumulation at dryer vent
